MTP-P&VE-M-62-6

March 5, 1962

**GEORGE C. MARSHALL**

AGING OF INSTALLED RUBBER AND PLASTIC  
GASKETS IN SIMULATED FLIGHT HARDWARE

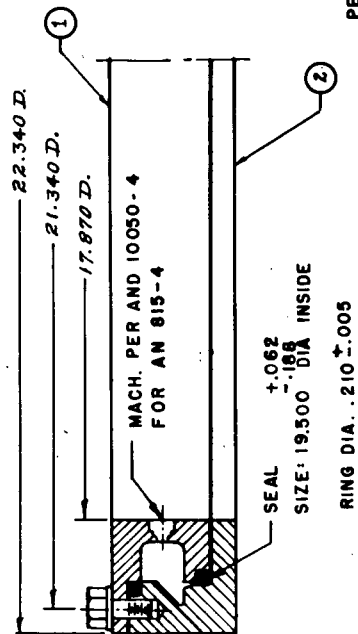
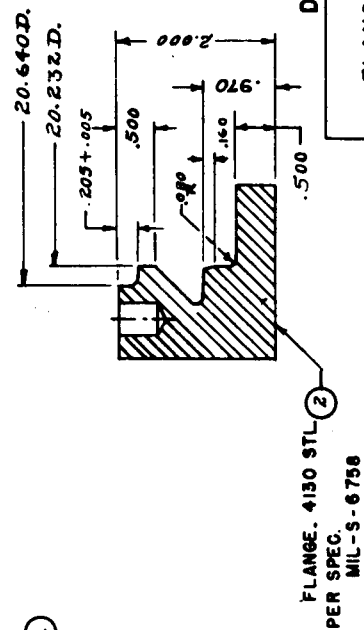
DWG. NO. MR-73-1

FLANGE ASSEMBLY  
THRUST CHAMBER

Detailed drawings for the various types of test fixtures (flanges and valves) used to contain the gaskets are shown in Appendix B, drawings MR-73-1 thru MR-73-11. The various bolted type flanges are shown in drawings MR-73-1 thru MR-73-6. Drawing MR-73-5 (stainless steel) and MR-73-6 (aluminum) contain a diaphragm separation plate and two o-ring gaskets per fixture. In some cases, the drawing number designates a type of fixture that is common to more than one type of gasket. For example, in drawing MR-73-2, FIG. 2A is for a Flexitallic gasket, FIG. 2B for an o-ring, FIG. 2C for Allpax and flat gaskets, and FIG. 2D for flat gaskets. Drawing MR-73-3 is essentially the same as MR-73-2 except that the flanges are made of stainless steel instead of aluminum.

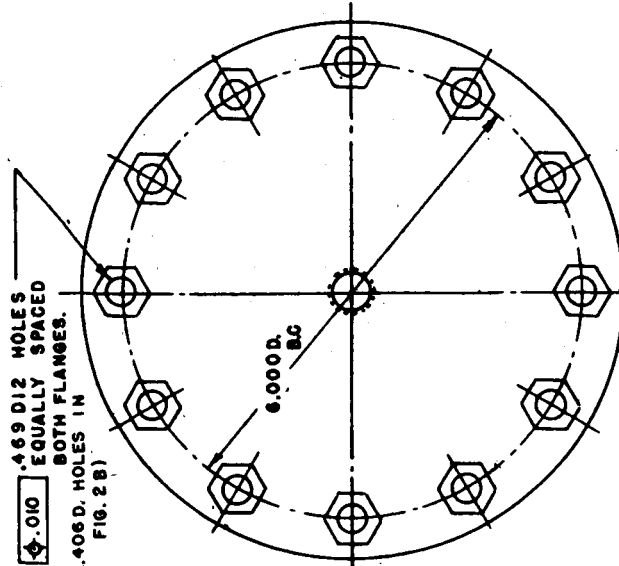
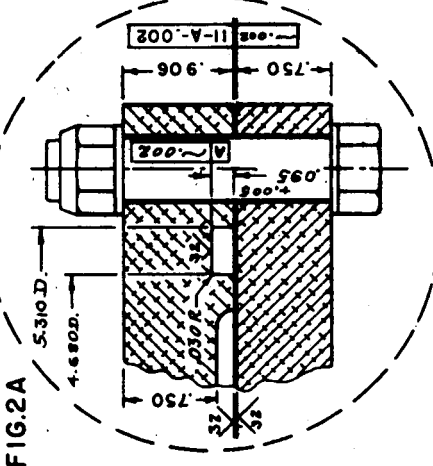
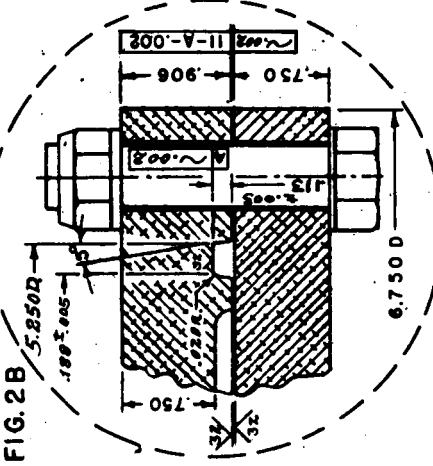
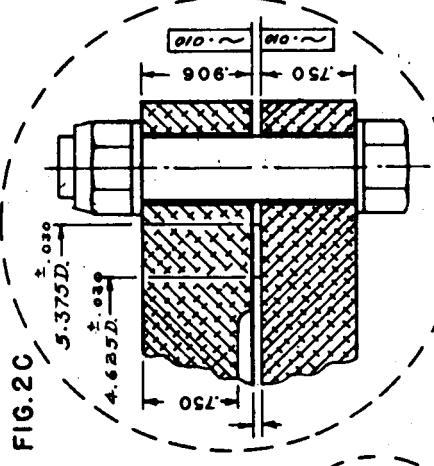
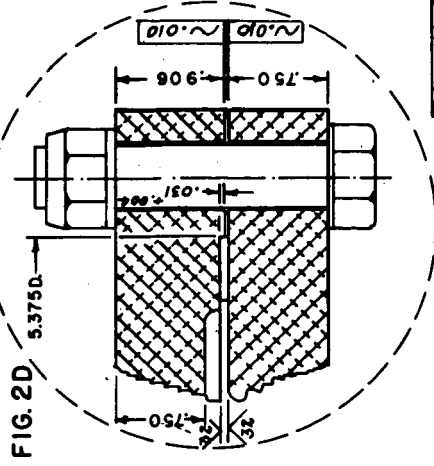
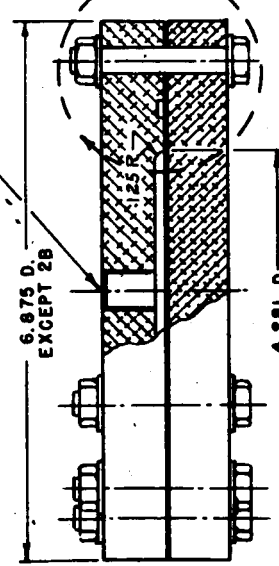
DWG. NO. MR-73-2

- NOTES:
1. ALL OVER EXCEPT AS SHOWN.
  2. DIMENSIONS ARE IN INCHES.
  3. FLANGE MATERIAL-6061 T6 AL ALLOY.  
(ANODIZE PER MIL-A-8625)

GASKET TEST  
ASSEMBLY

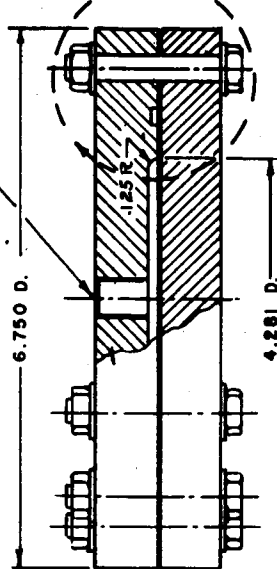
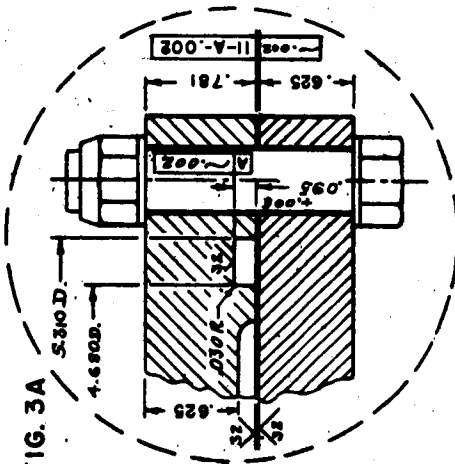
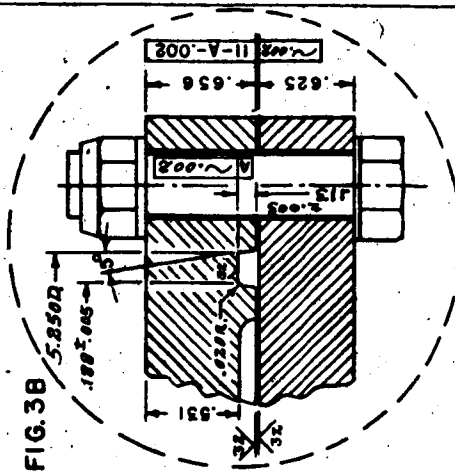
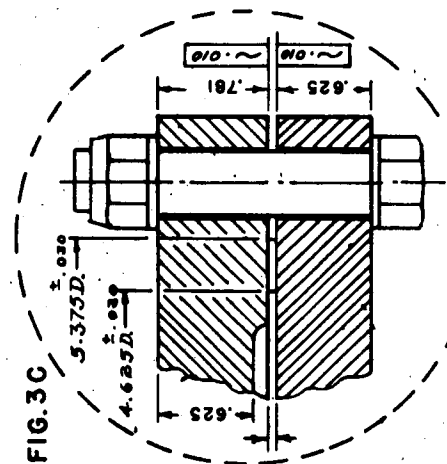
FIG. 3A

FIG. 3B

FIG. 3C

1. ALL OVER EXCEPT AS SHOWN.
2. DIMENSIONS ARE IN INCHES.
3. FLANGE MATERIAL - 321 CRES. STEEL

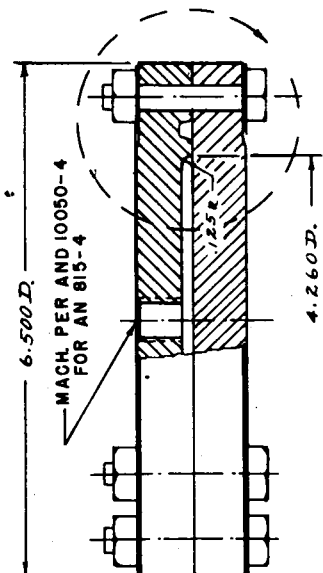
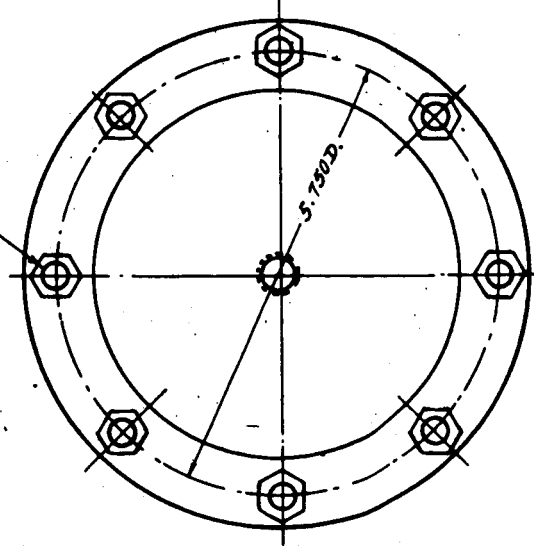
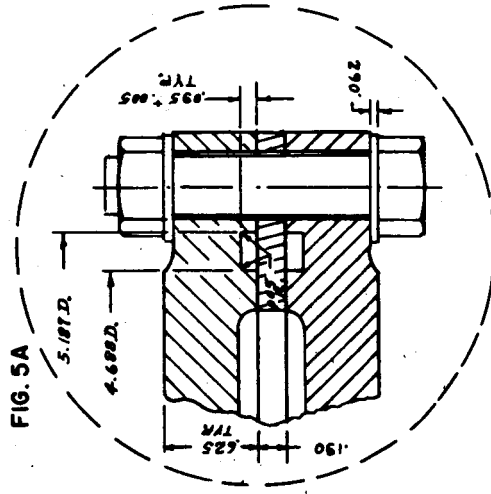
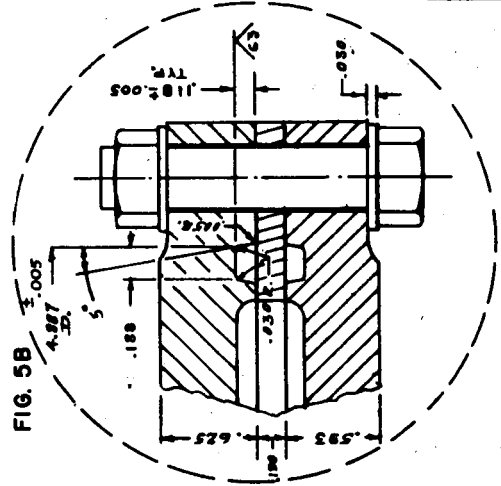
DWG. NO. MR-73-4

- NOTES:
1. DIMENSIONS ARE IN INCHES.
  2.  $\frac{.05}{.05}$  ALL MACHINED SURFACES UNLESS OTHERWISE SHOWN.
  3. 321 CRES STEEL—
  4. 6061 T6 AL ALLOY—  
(ANODIZE PER MIL-A-8625)

GASKET TEST  
ASSEMBLY

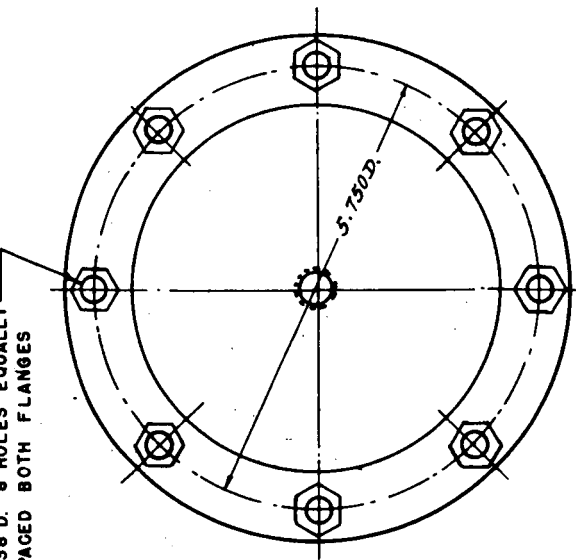
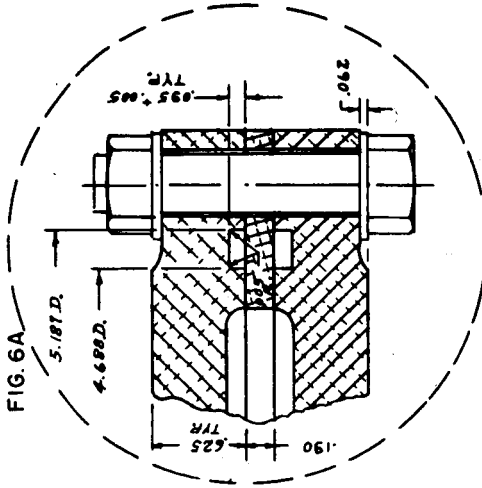
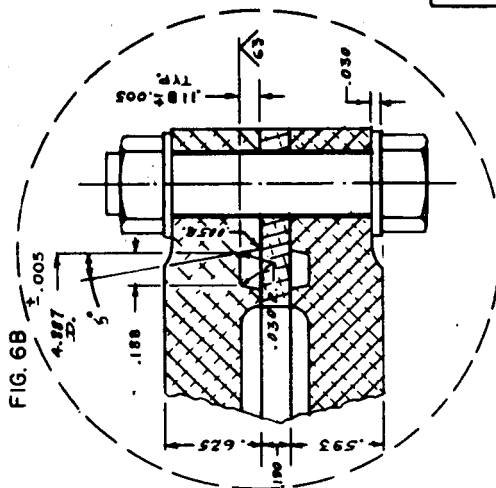
DWG. NO. MR-73-5

1. ALL DIMENSIONS ARE IN INCHES.
2. <sup>125</sup>/<sub>16</sub> ALL MACHINED SURFACES UNLESS OTHERWISE SHOWN.
3. FLANGE MATERIAL 321 CRES STEEL.

# GASKET TEST ASSEMBLY

Six out of six Flexitallic gaskets in aluminum fixtures (MR-73-6A) failed at 750 psi pressure in six months at MSFC and in one year in Florida. In stainless steel fixtures (MR-73-5A), two out of three Flexitallic

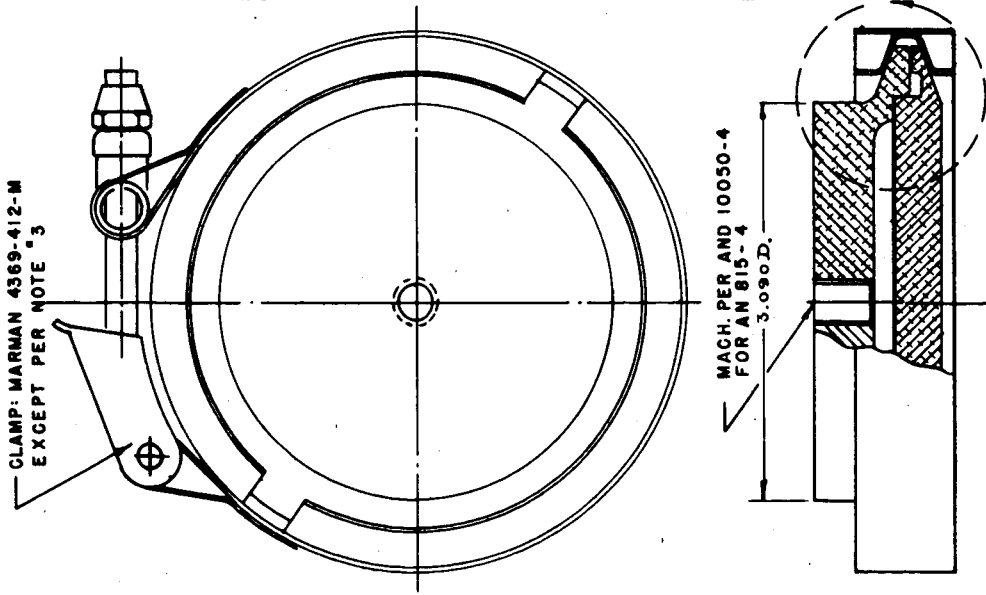
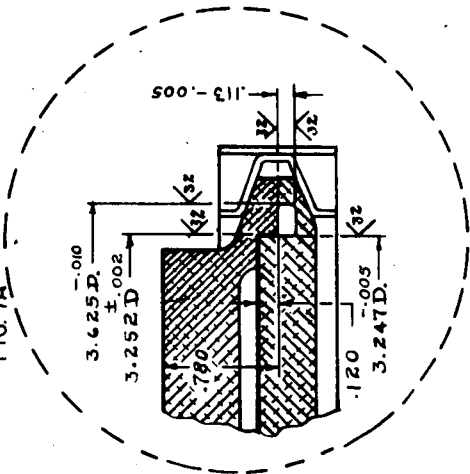
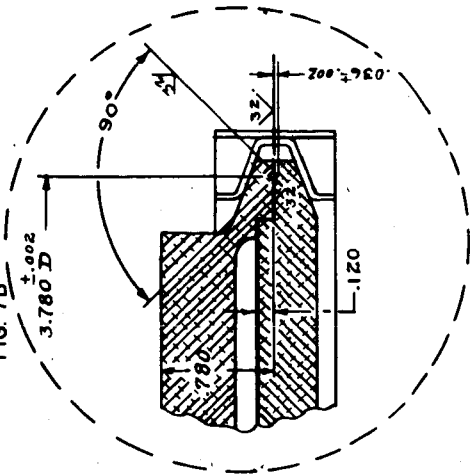
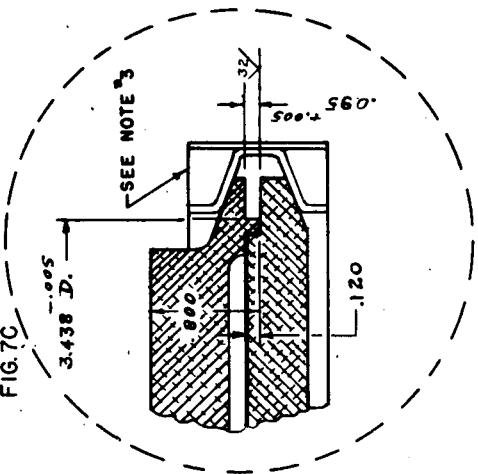
DWG. NO. MR-73-7

CLAMP: MARMAN 4369-412-M  
EXCEPT PER NOTE "3"

- NOTES:
1. ALL MACHINED SURFACES.
  2. DIMENSIONS ARE IN INCHES.
  3. MARMAN 4426-410-M
  4. 6061 T6 AL ALLOY — (ANODIZE PER MIL-A-8625)

GASKET TEST  
ASSEMBLY

Drawing MR-73-7 shows a Marman flange constructed of 6061 aluminum. In this drawing, FIG. 7A is for o-ring, FIG. 7B for a stainless steel o-ring, and FIG. 7C for a Flexitallic gasket. Drawing MR-73-8 shows a Marman flange designed specifically for determining the effect of galvanic corrosion of dissimilar metals, aluminum and stainless steel.

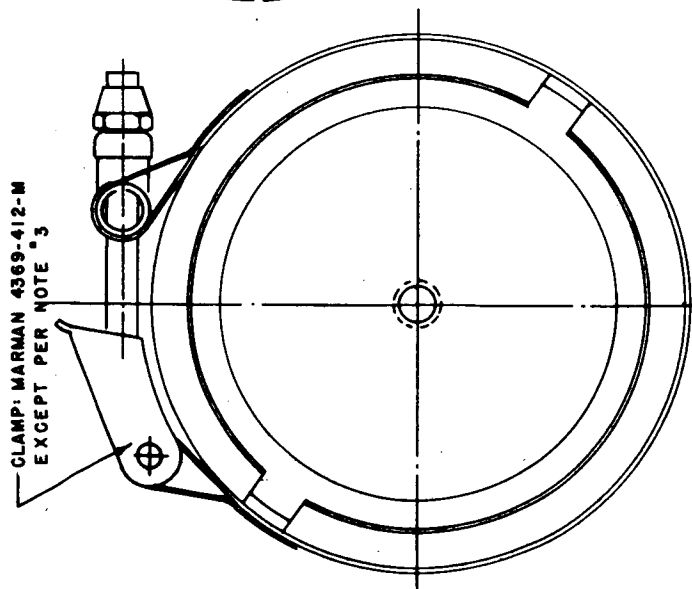
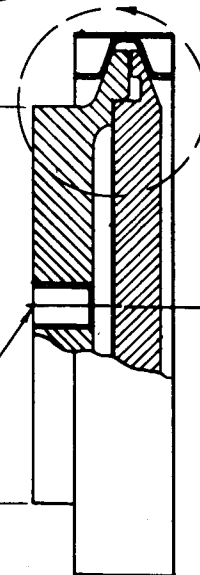
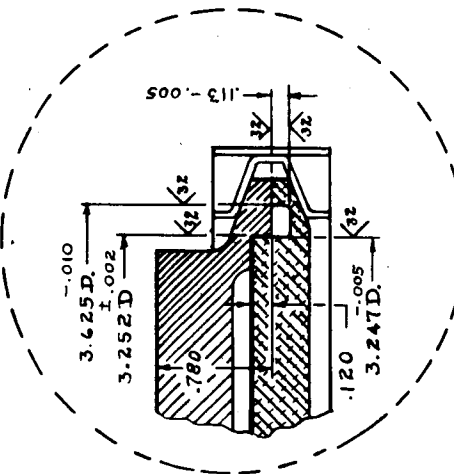
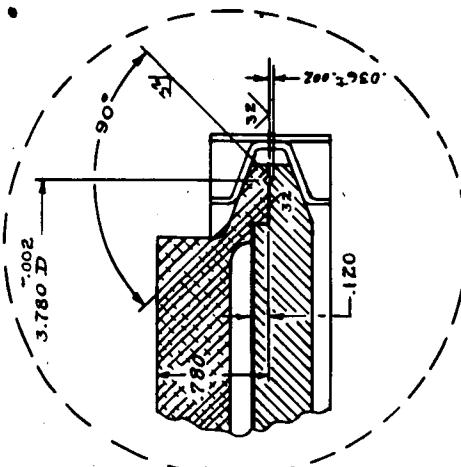
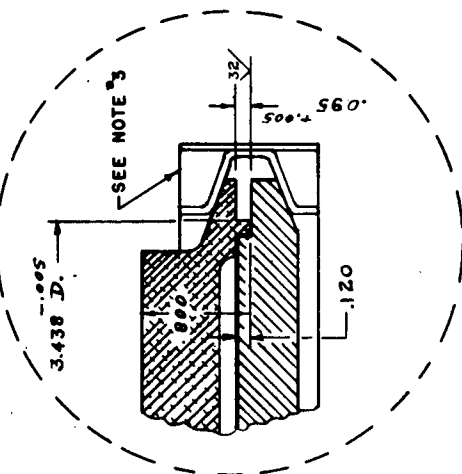
DWG. NO. MR-73-8

1. ALL MACHINED SURFACES.  
2. DIMENSIONS ARE IN INCHES.  
3. MARMAN 4426-410-M  
4. 6061 T6 AL ALLOY — (ANODIZE PER MIL-A-8625)

## GASKET TEST ASSEMBLY

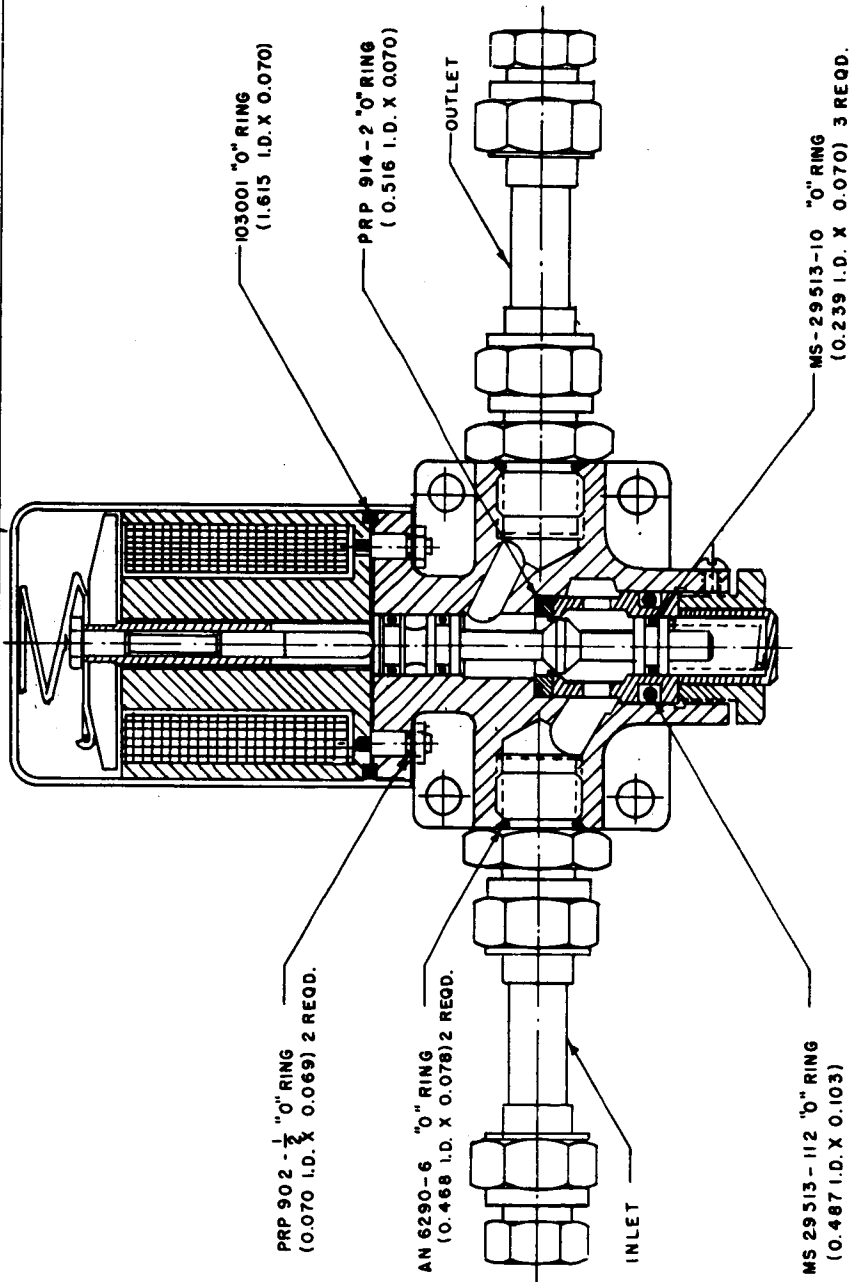
DWG NO. MR-73-9

VALVE ASSEMBLY  
SOLENOID MV-76

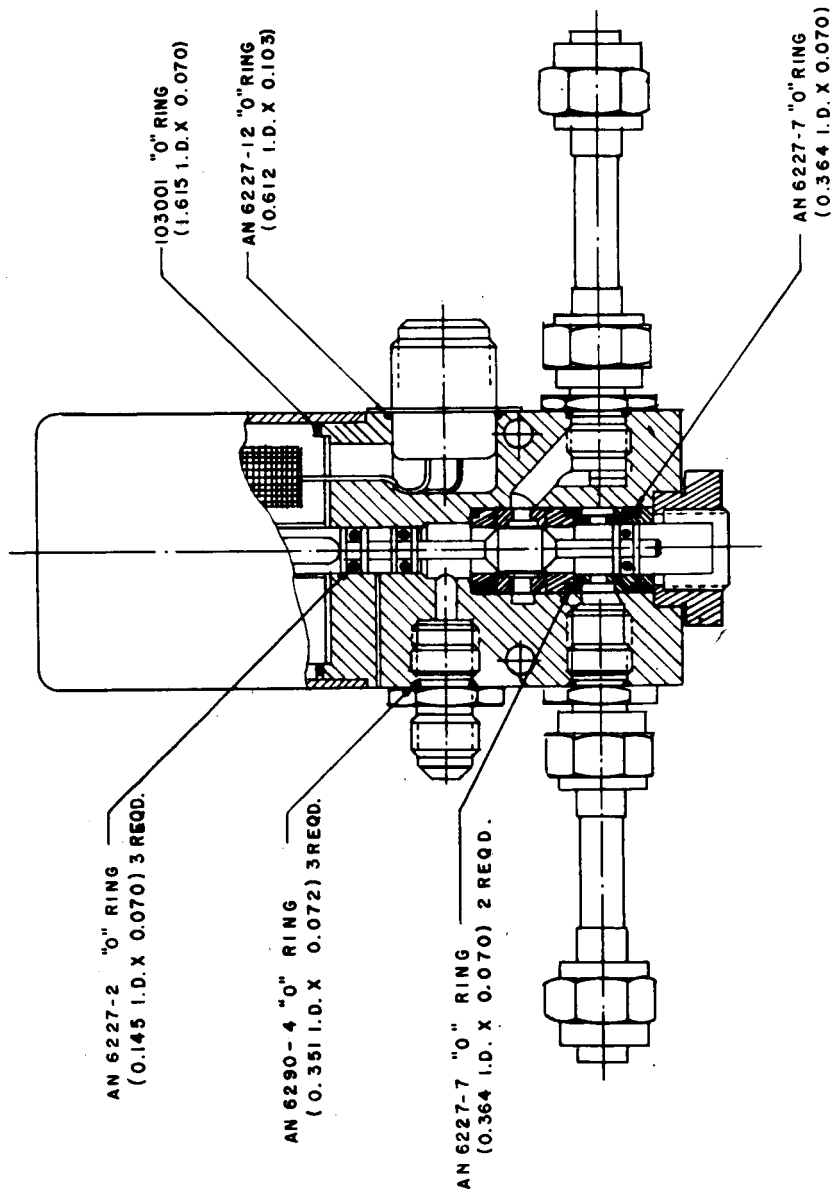
DWG. NO. MR-73-10

CONTROL VALVE  
MV-74

No failures occurred with the commercial rubber o-ring gaskets over test periods ranging from two years (MSFC) to two and one-half years (Gainesville). However, one MV-74 valve leaked after two years at MSFC, but this did not constitute failure as defined. As previously defined, failure required that two out of three gaskets leak in excess of allowable tolerances.

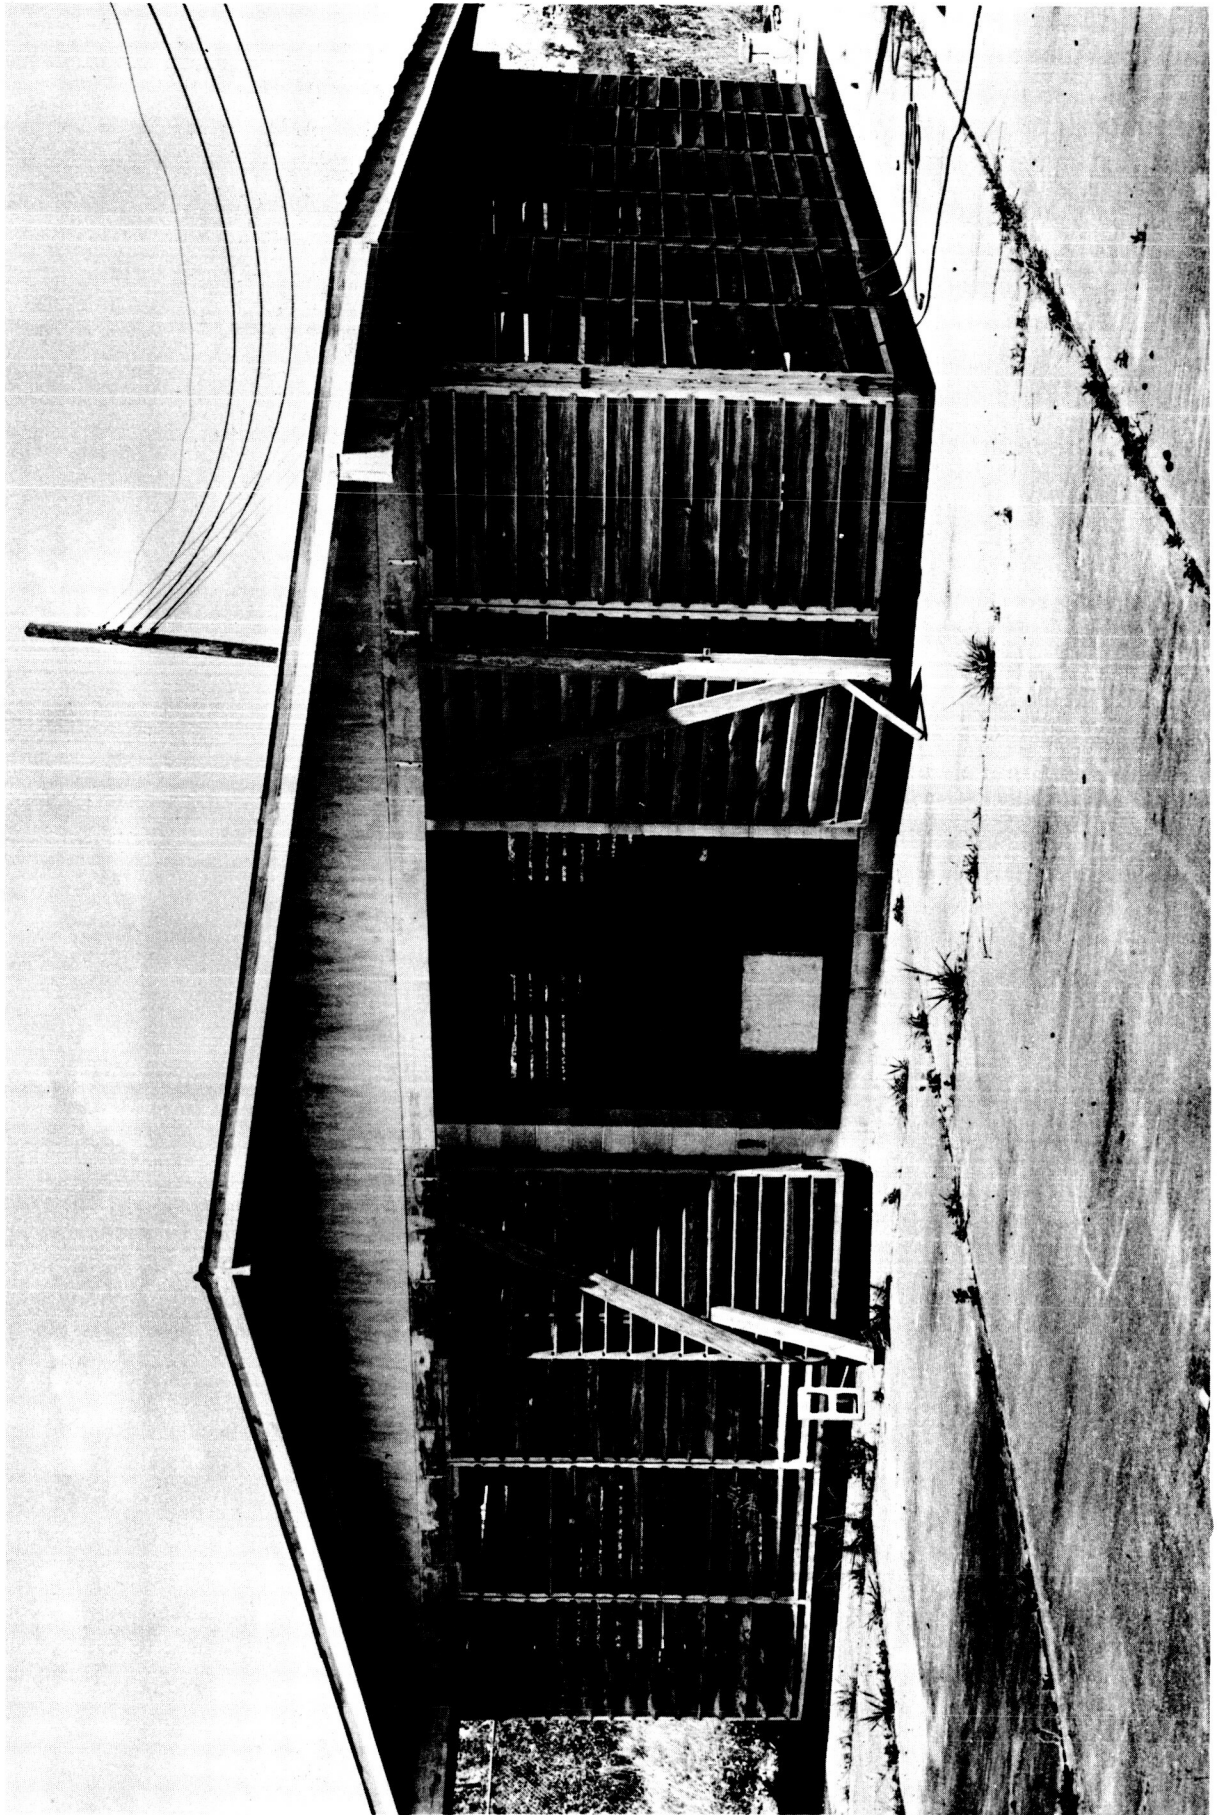
FIGURE 1 TEST FACILITIES AT GAINESVILLE, FLORIDA

Duplicate tests are in progress at Gainesville, Florida and Marshall Space Flight Center. Under contract (NAS8-1523) with the University of Florida, the exposure building, personnel assistance, and minor supplies were provided. The exposure site is situated approximately ten miles from Gainesville, adjacent to the Municipal Airport. The building was designed to protect the test fixtures against direct exposure to the elements, but otherwise allows them to be exposed to the prevailing ambient atmospheric conditions. A photograph of this structure is shown in Appendix D, FIG. 1.

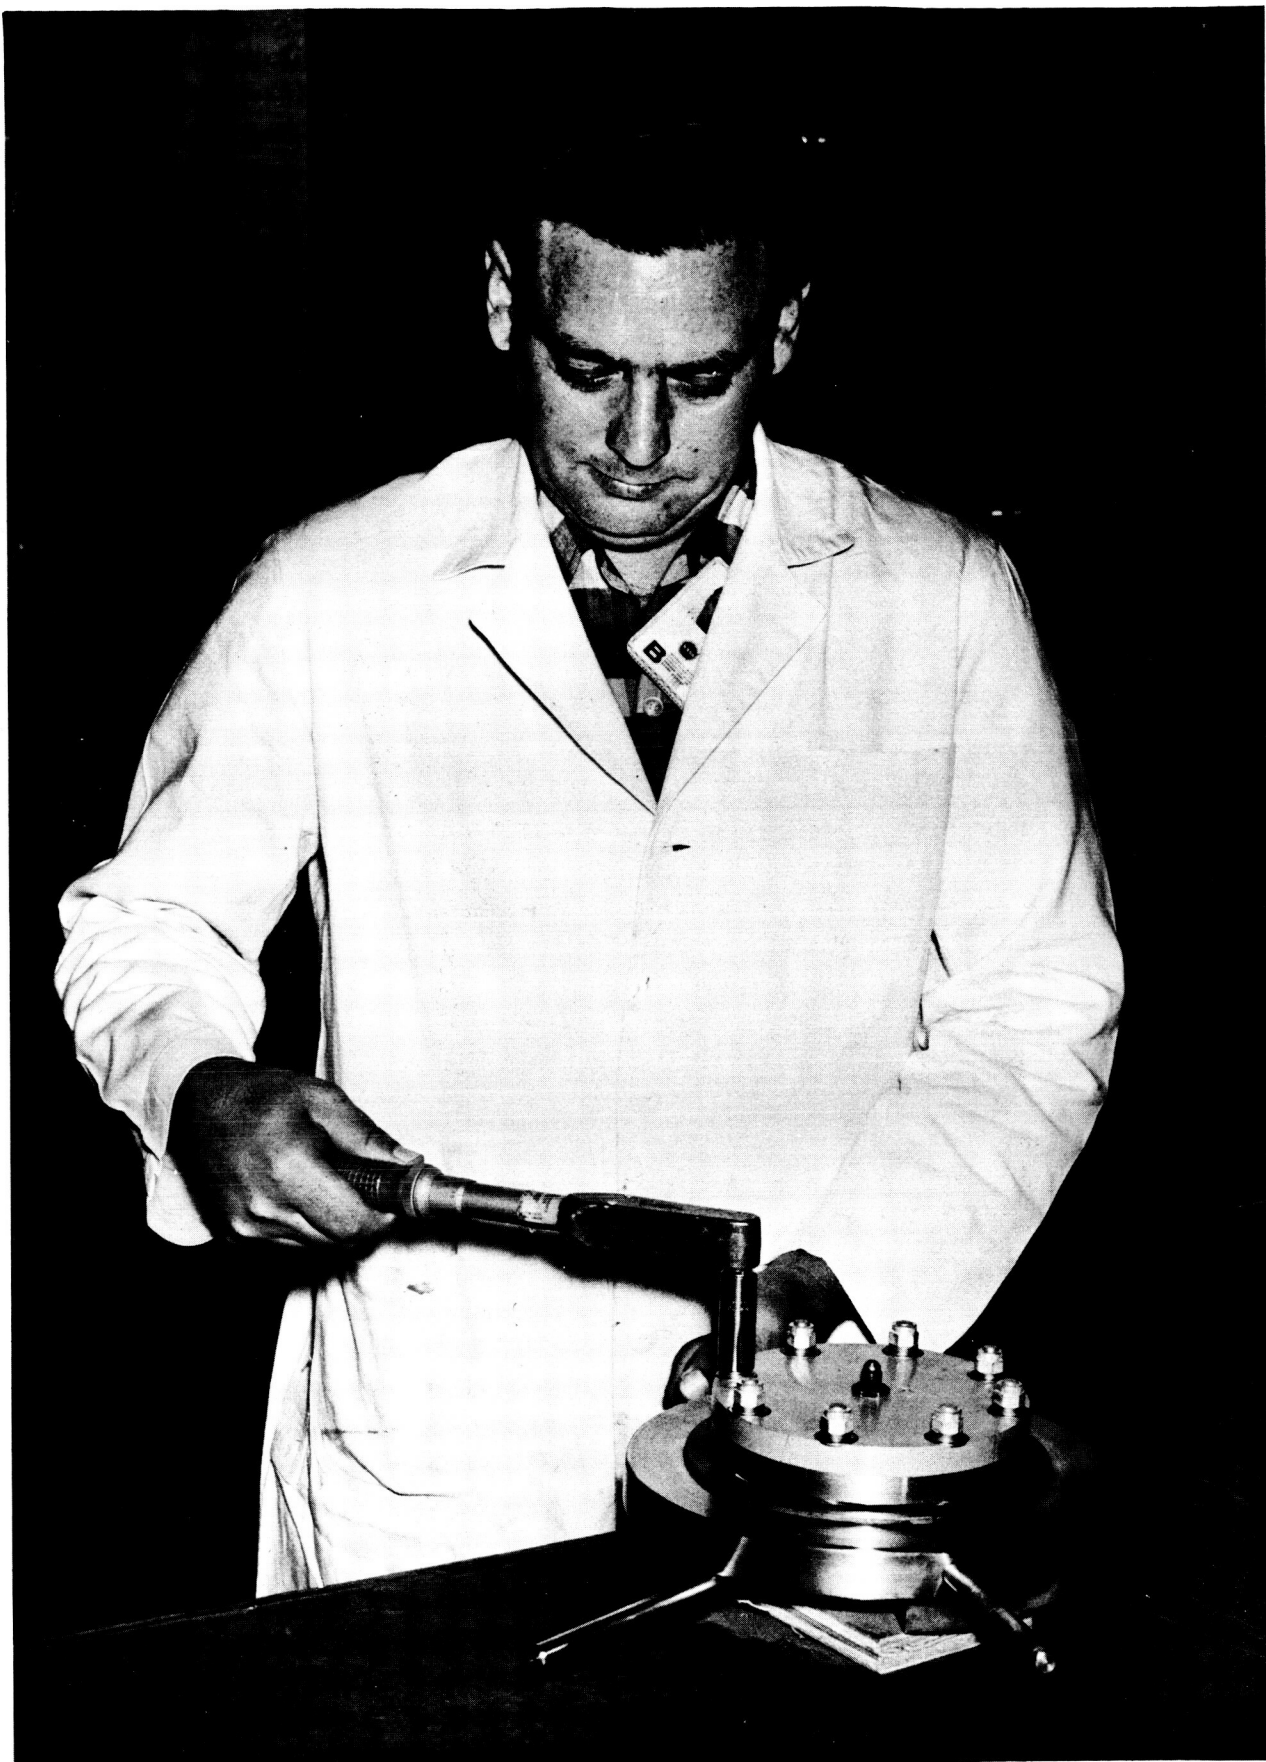
FIGURE 2 TEST FIXTURE ASSEMBLY

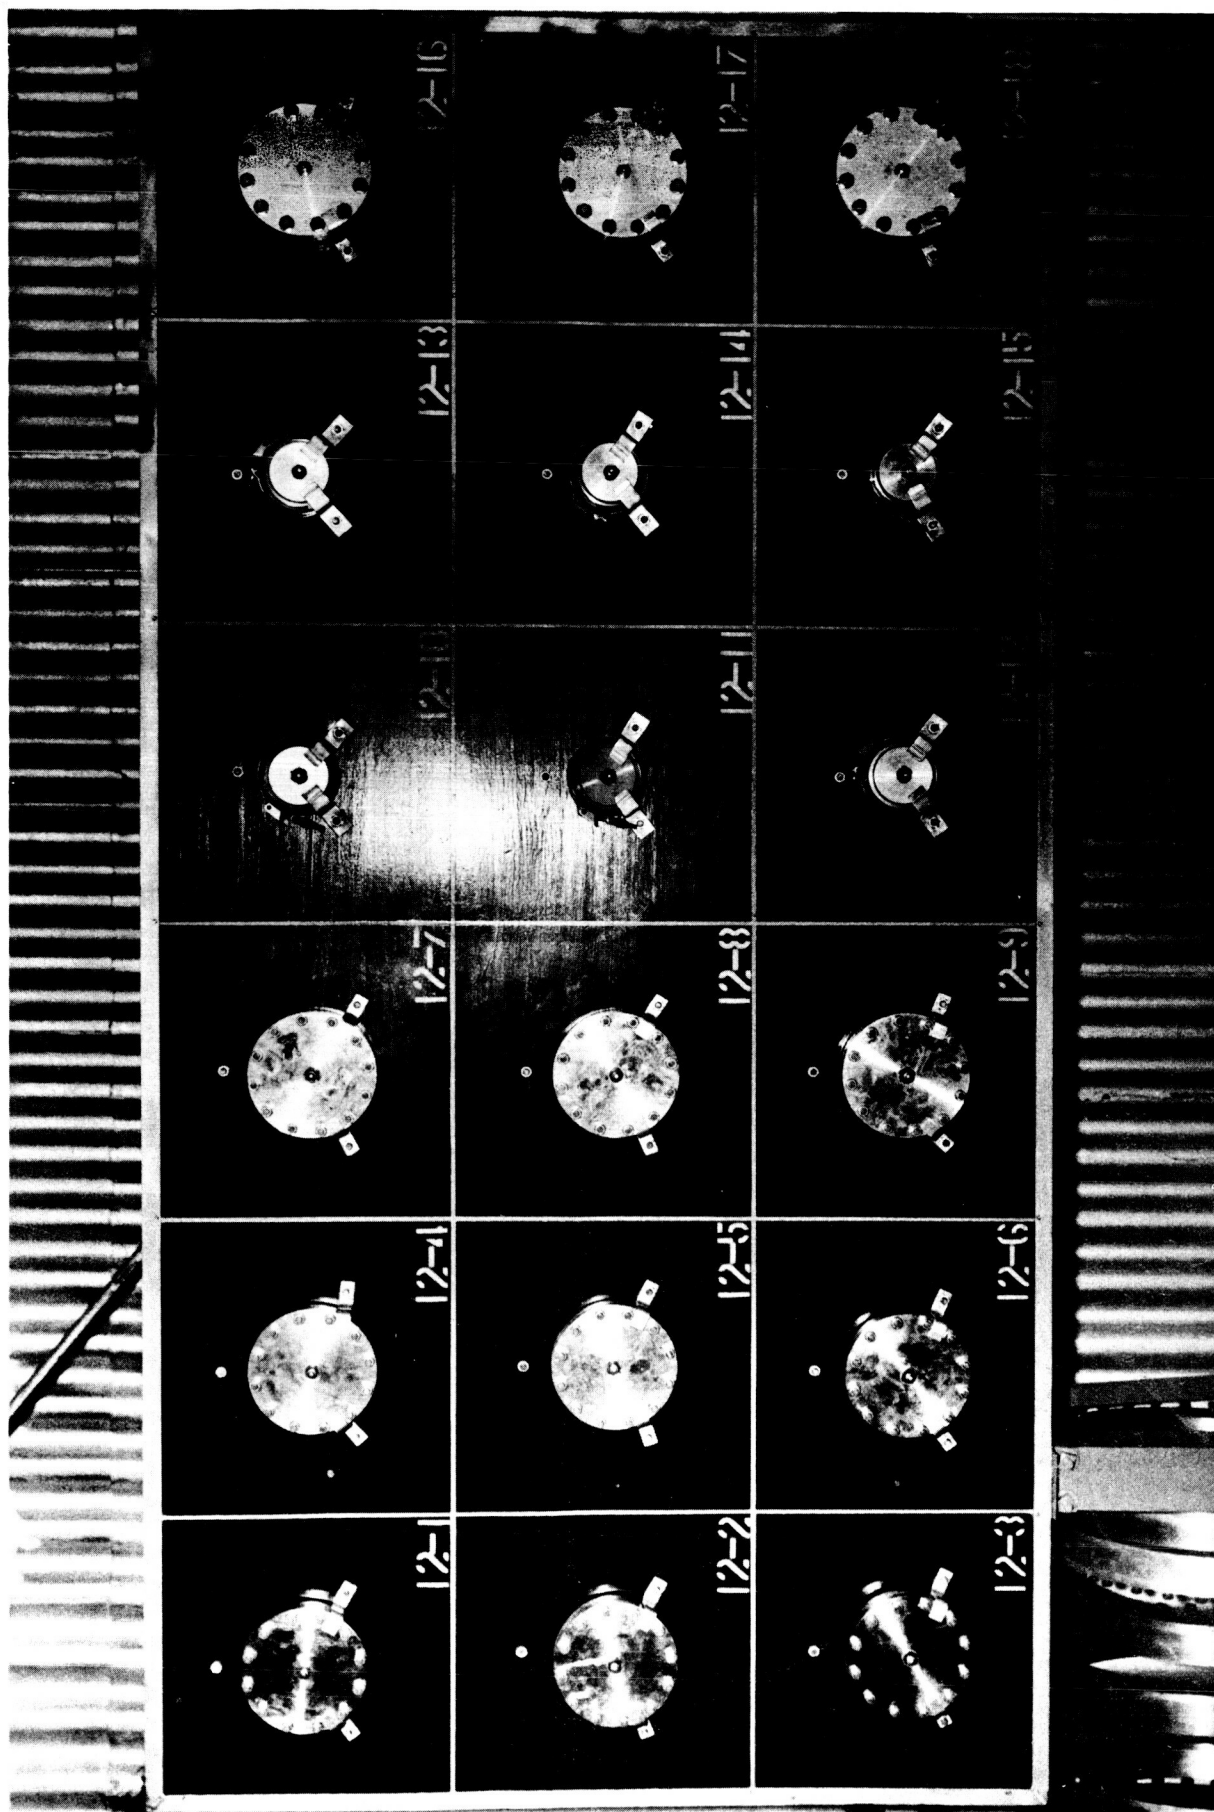
FIGURE 3 INSTALLED TEST FIXTURES

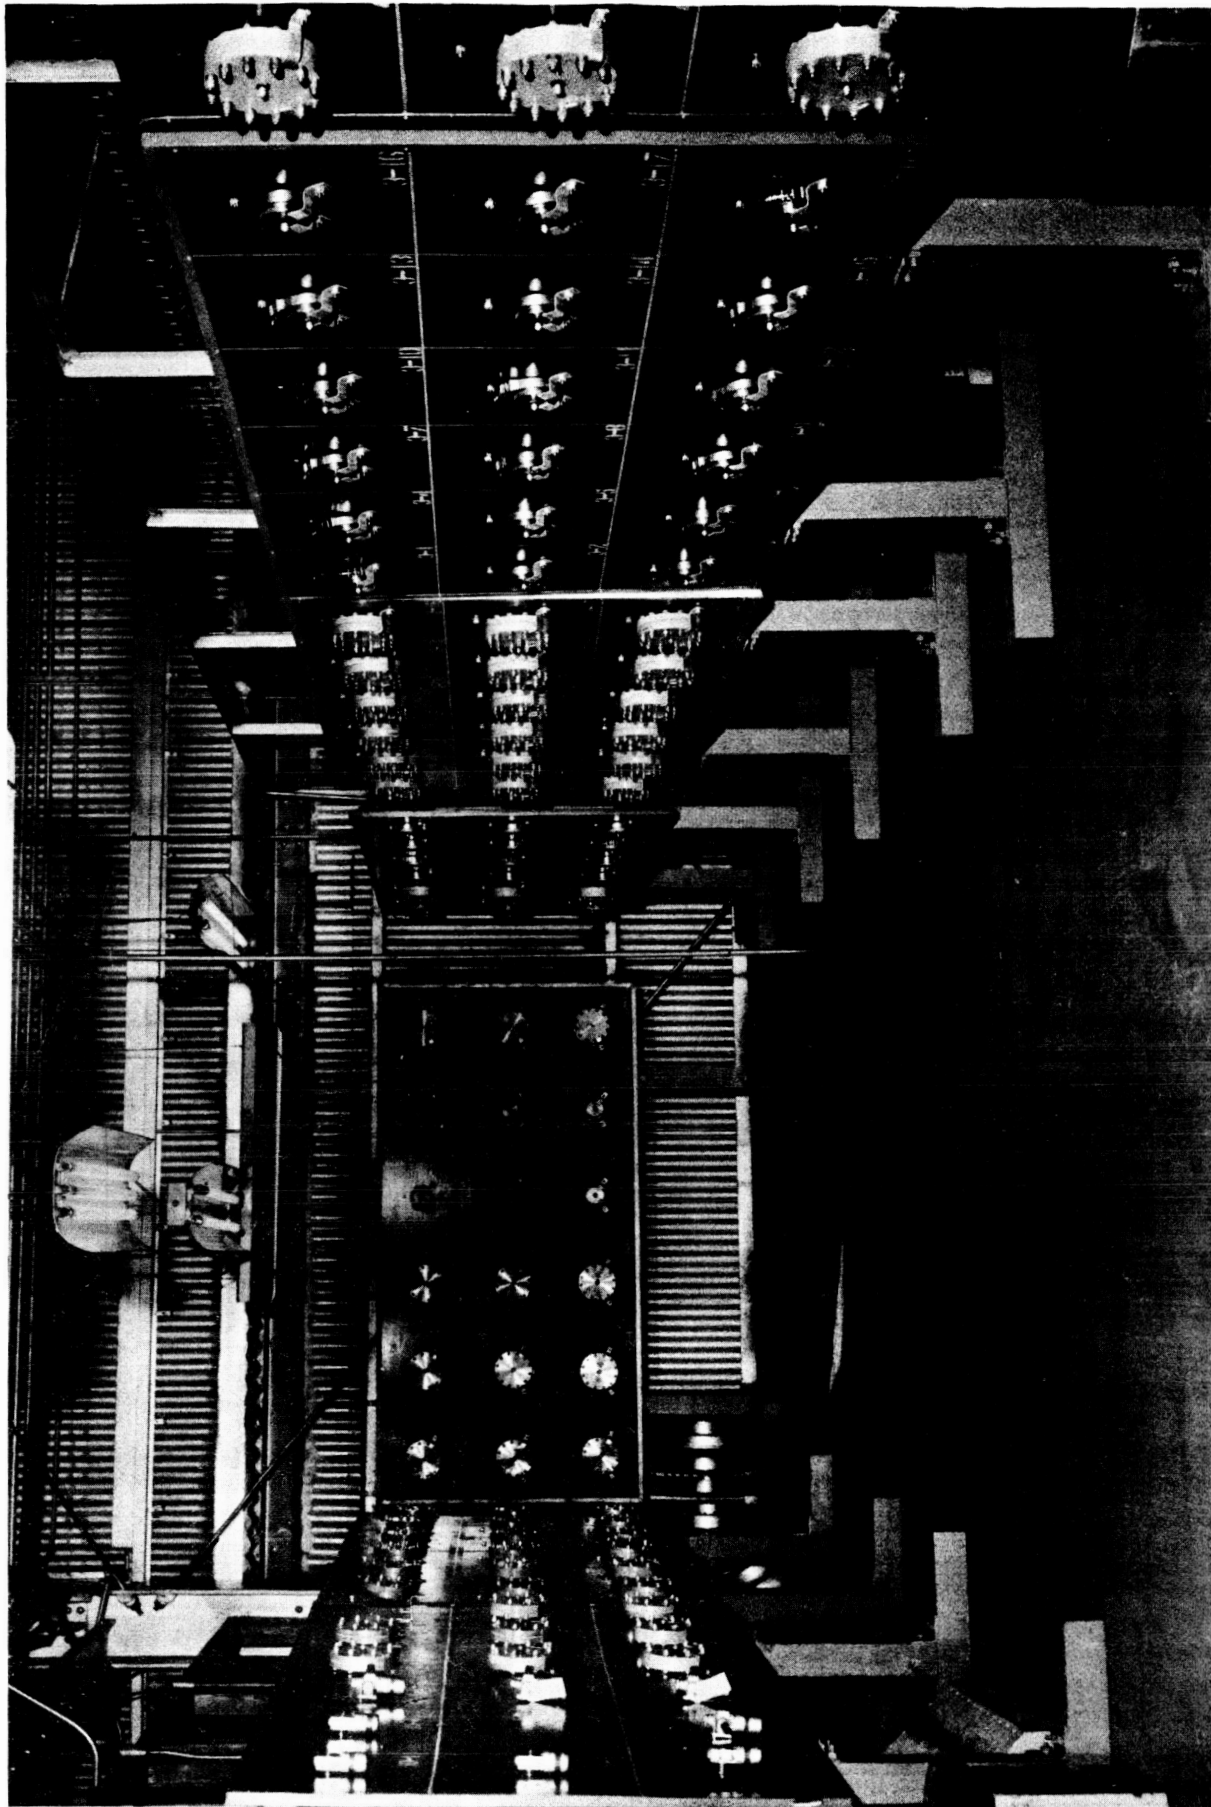
FIGURE 4 INSTALLED TEST FIXTURES AT MSFC

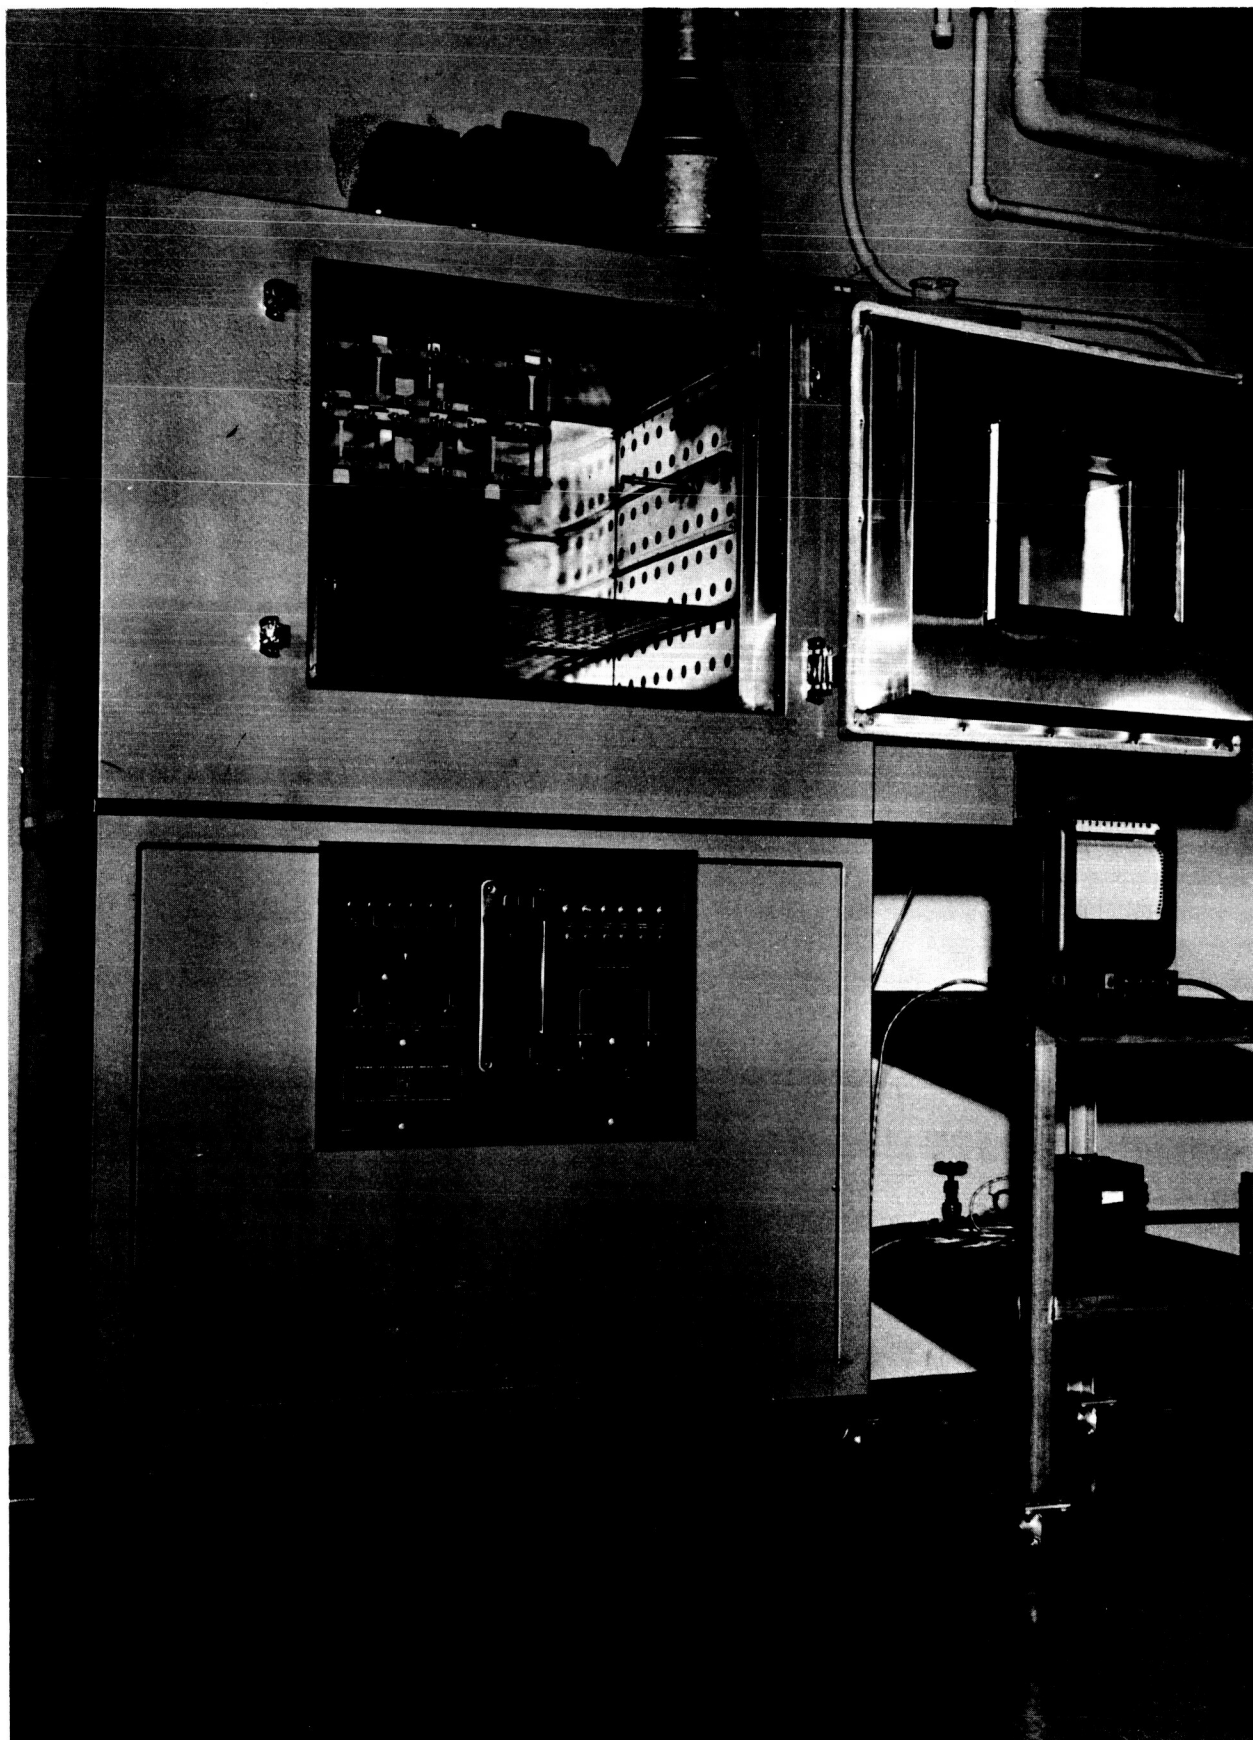
FIGURE 5 MAST OZONE TEST CHAMBER

Standard dumbbell specimens were tested in duplicate at 25 parts per hundred million (pphm) of ozone concentration for 0, 4, 8, 24 and 48 hours at ambient temperature in a Mast Ozometer, according to ASTM Method D-1149-55T. The procedure permitted dynamic cycling at the rate of 30 cycles per minute and 25% specimen elongation. The results of the 48-hour test are presented in Appendix A, Table 4. A photograph of the Mast Ozone Test Chamber is shown in Appendix D, FIG. 5. Examples of ozone cracks in natural rubber are shown in Appendix D, FIG. 6. The data show that the properties of natural, nitrile, and SBR rubbers were adversely affected by 25 pphm ozone in 48 hours.

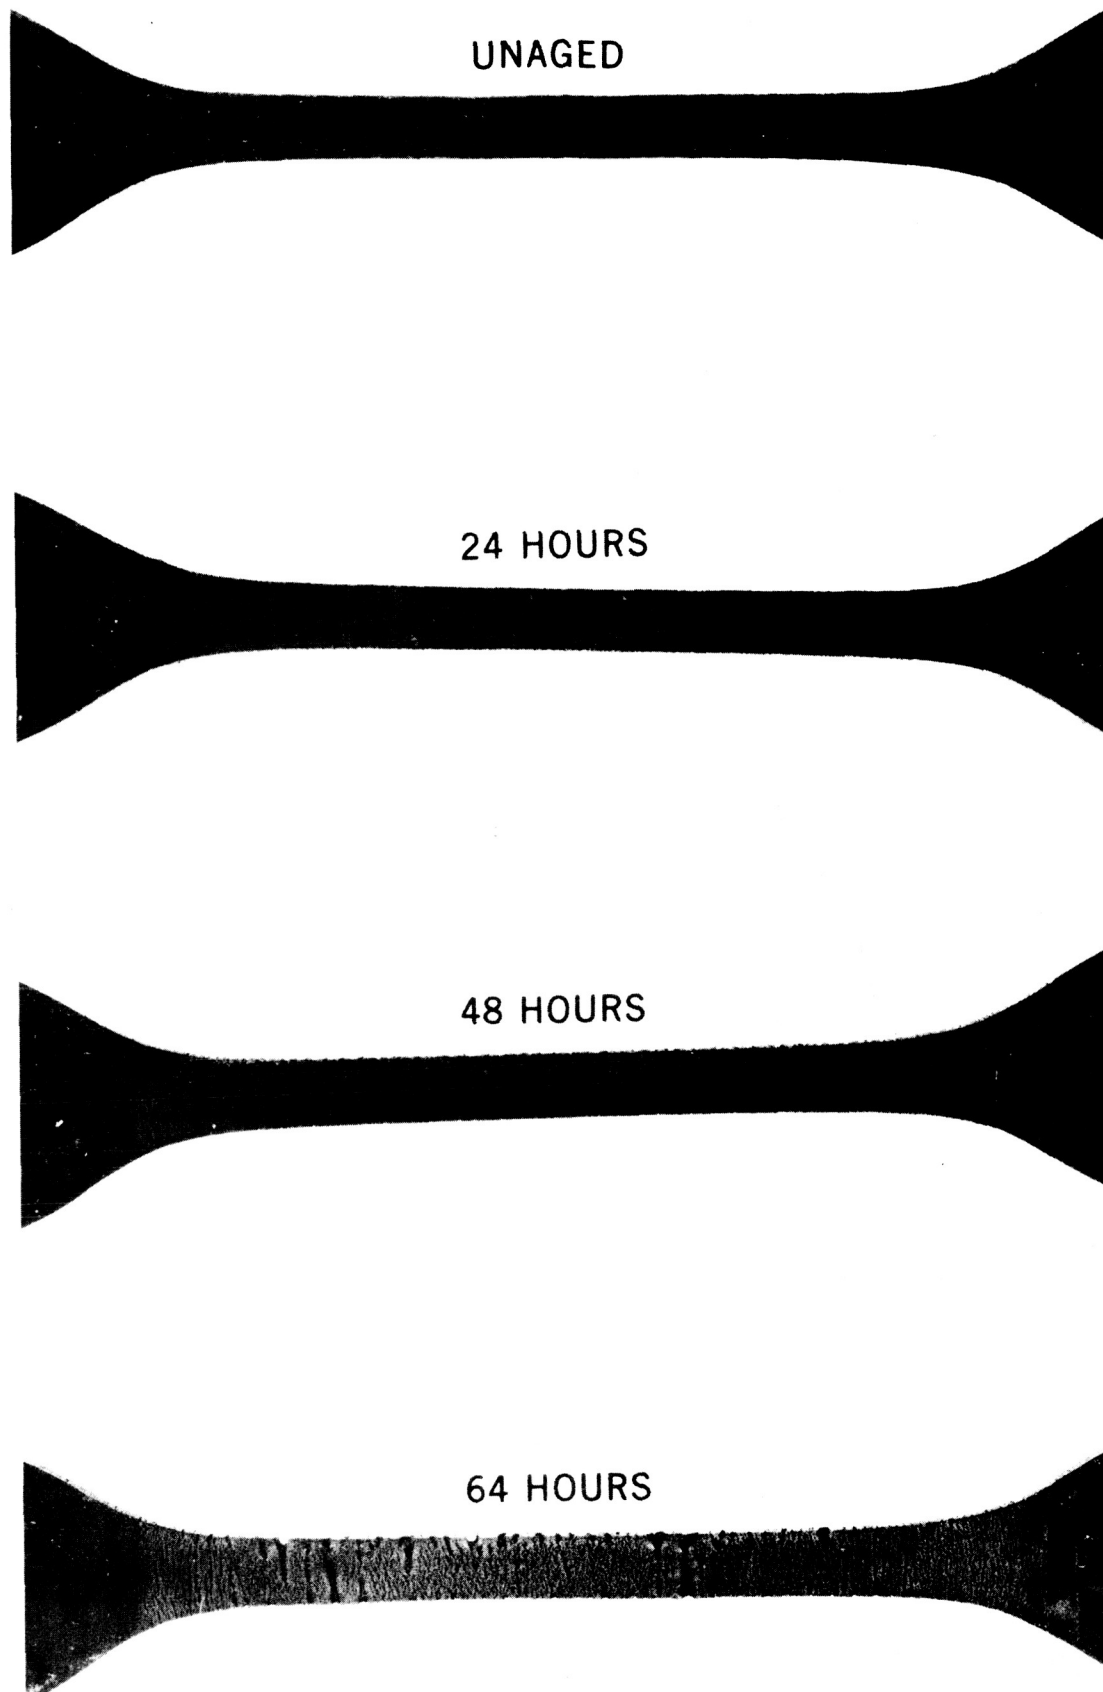
FIGURE 6 ACCELERATED OZONE AGING OF NATURAL RUBBER,  
25 PPHM OZONE AT AMBIENT TEMPERATURE
